**Evaluation of Functional Connectivity
for Medium- to Large-bodied
Carnivores and Mule Deer across
Colima Road in the Puente Hills
Preserve, City of Whittier, California**

City of Whittier

SWCA Environmental Consultants

January 2012

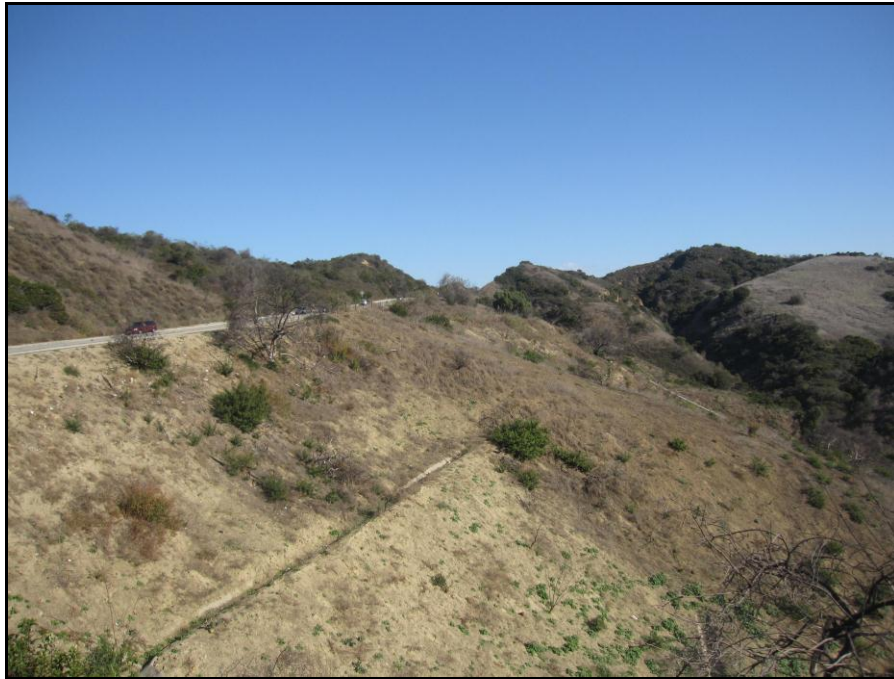
Figure 2. Example of a fill slope (fill slope 4).

Fill slopes were any location where the road was elevated relative to the surrounding topography and positioned on top of dirt fill, and typically occurred where the road bisected a drainage (Figure 2).

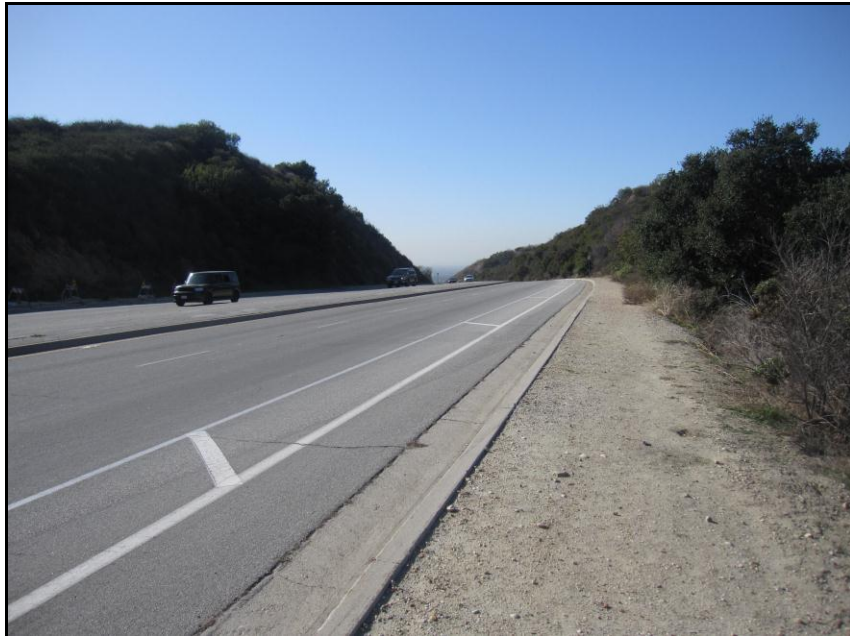
Figure 3. Cut slopes along Colima Road.

One large cut slope was located at the crest of Colima Road. The adjacent topography on either side of the road was considered substantial enough (i.e., high enough above the road grade) to facilitate the construction of an overpass structure. Cut slopes were recorded on the east side of Colima Road between fill slopes 4 and 5 and along the west side of Colima Road between fill slope 6 and the northern limit of fill slope 4 (Figure 3).

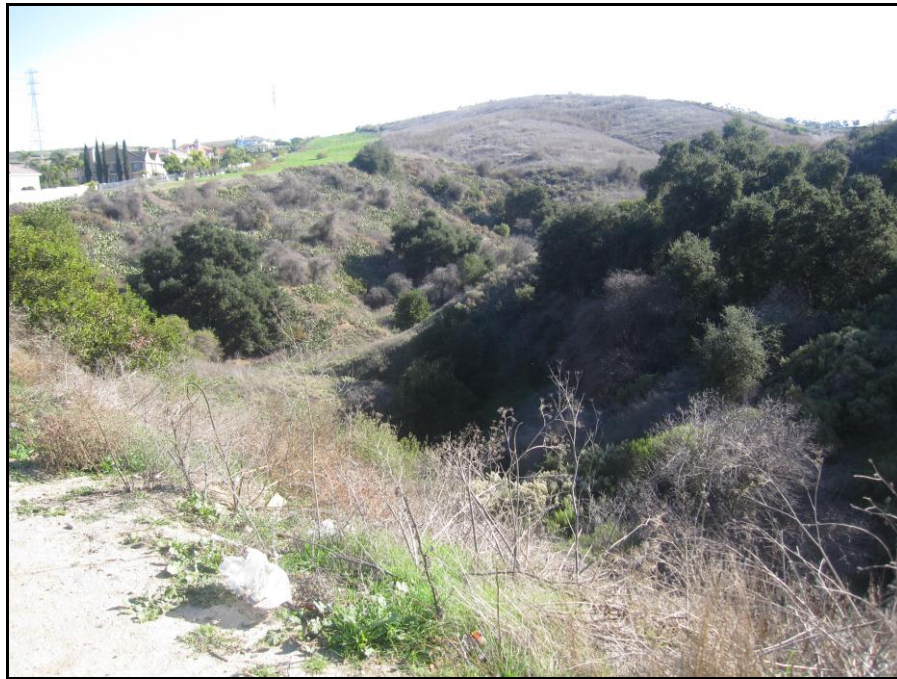
Figure 5. Looking east along upper Arroyo Pescadero along the northbound lands (east side) of Colima Road from site of the proposed underpass location, east portal.

Photographs of Arroyo Pescadero Canyon extending east and west from the proposed underpass location are provided in Figures 5 and 6, respectively. Aerial imagery of the proposed location is provided in Figures 7 through 10. These images depict the specific location of the structure relative to the urban edge to the north. Siting the structure as far away from the residential neighborhood to the north yet constructing it on the southern edge of fill slope 5 will achieve the following:

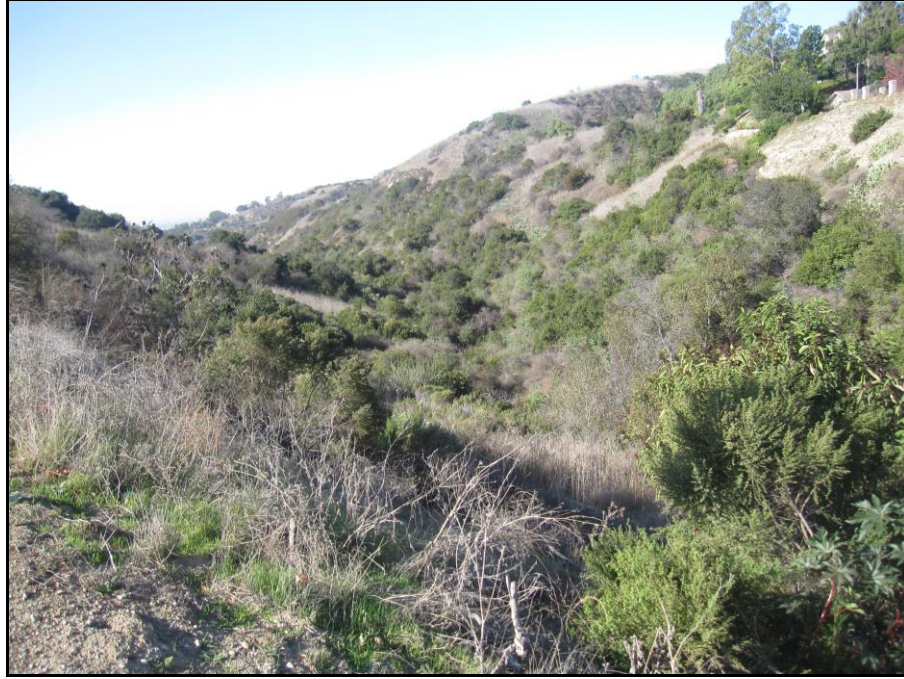
Figure 6. Looking west along upper Arroyo Pescadero along the southbound lands (west side) of Colima Road from site of the proposed underpass location, west portal.

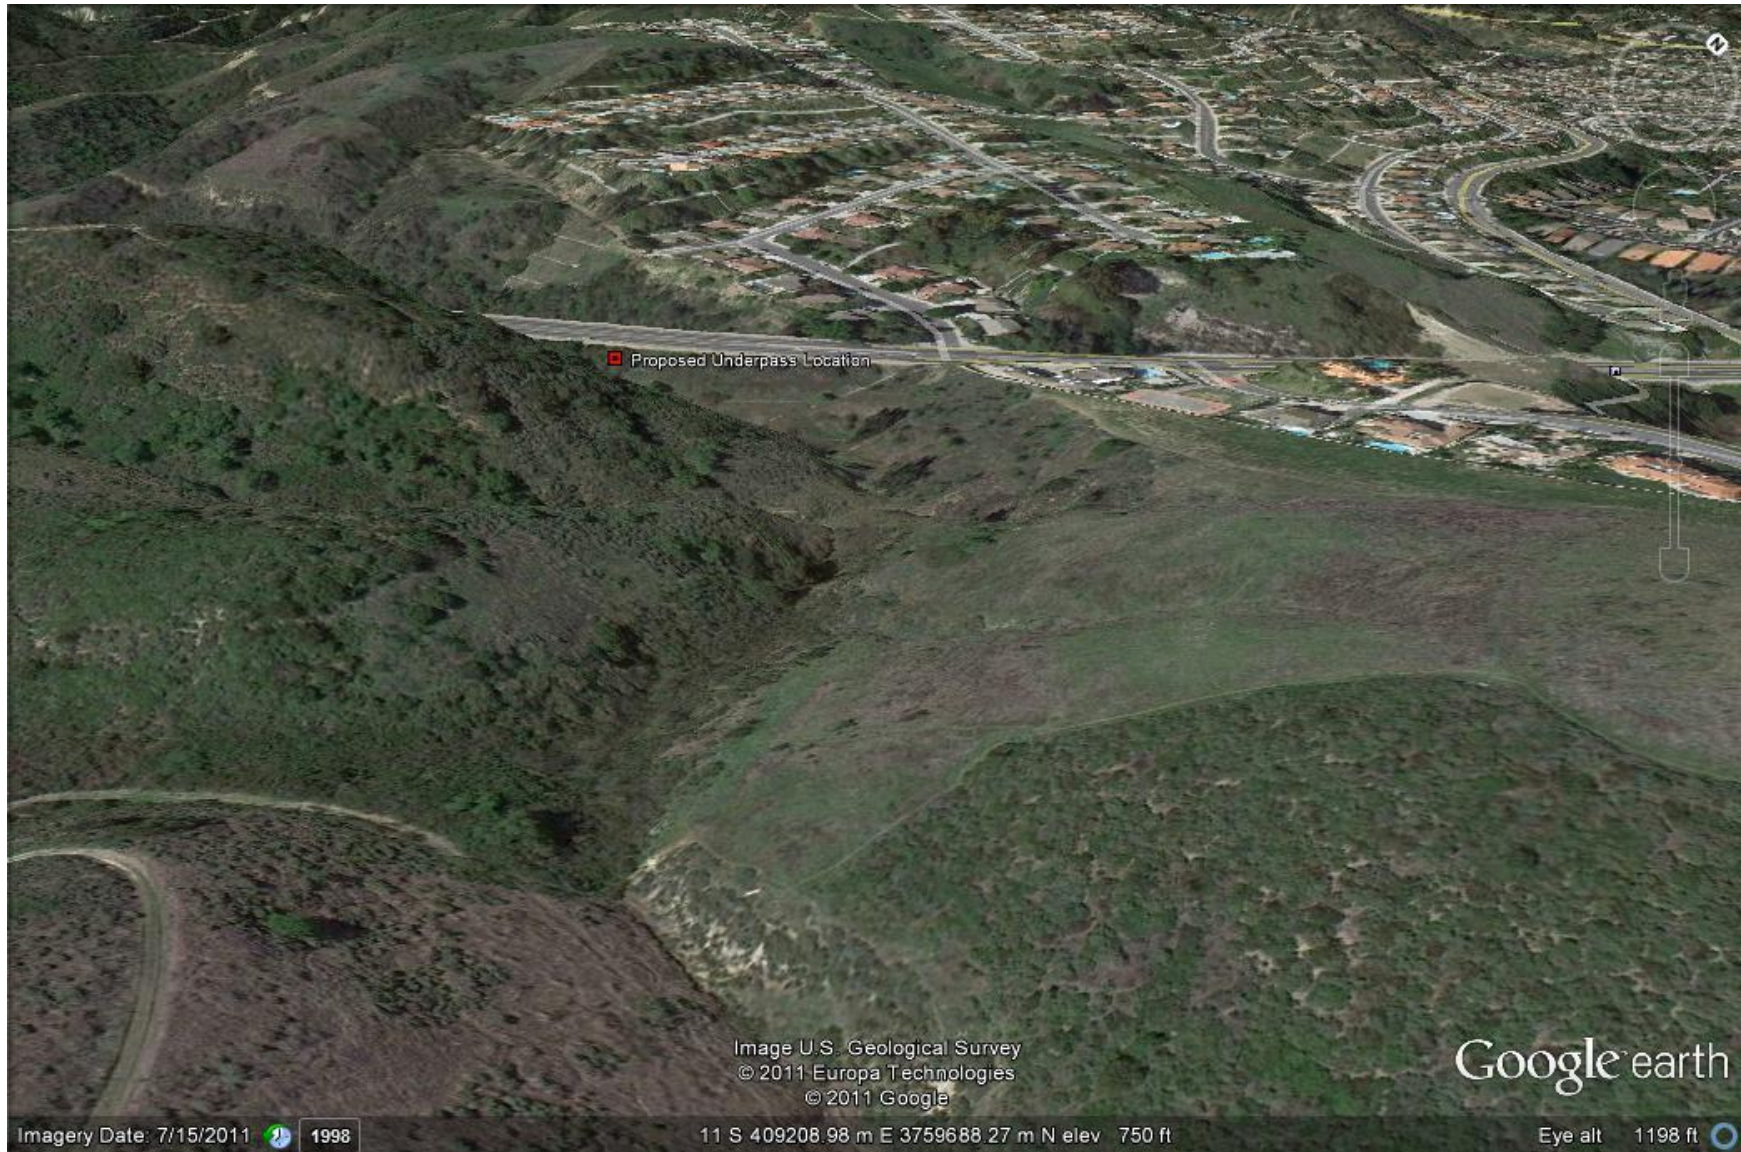
Figure 8. Looking west along upper Arroyo Pescadero at the proposed underpass location, east portal.

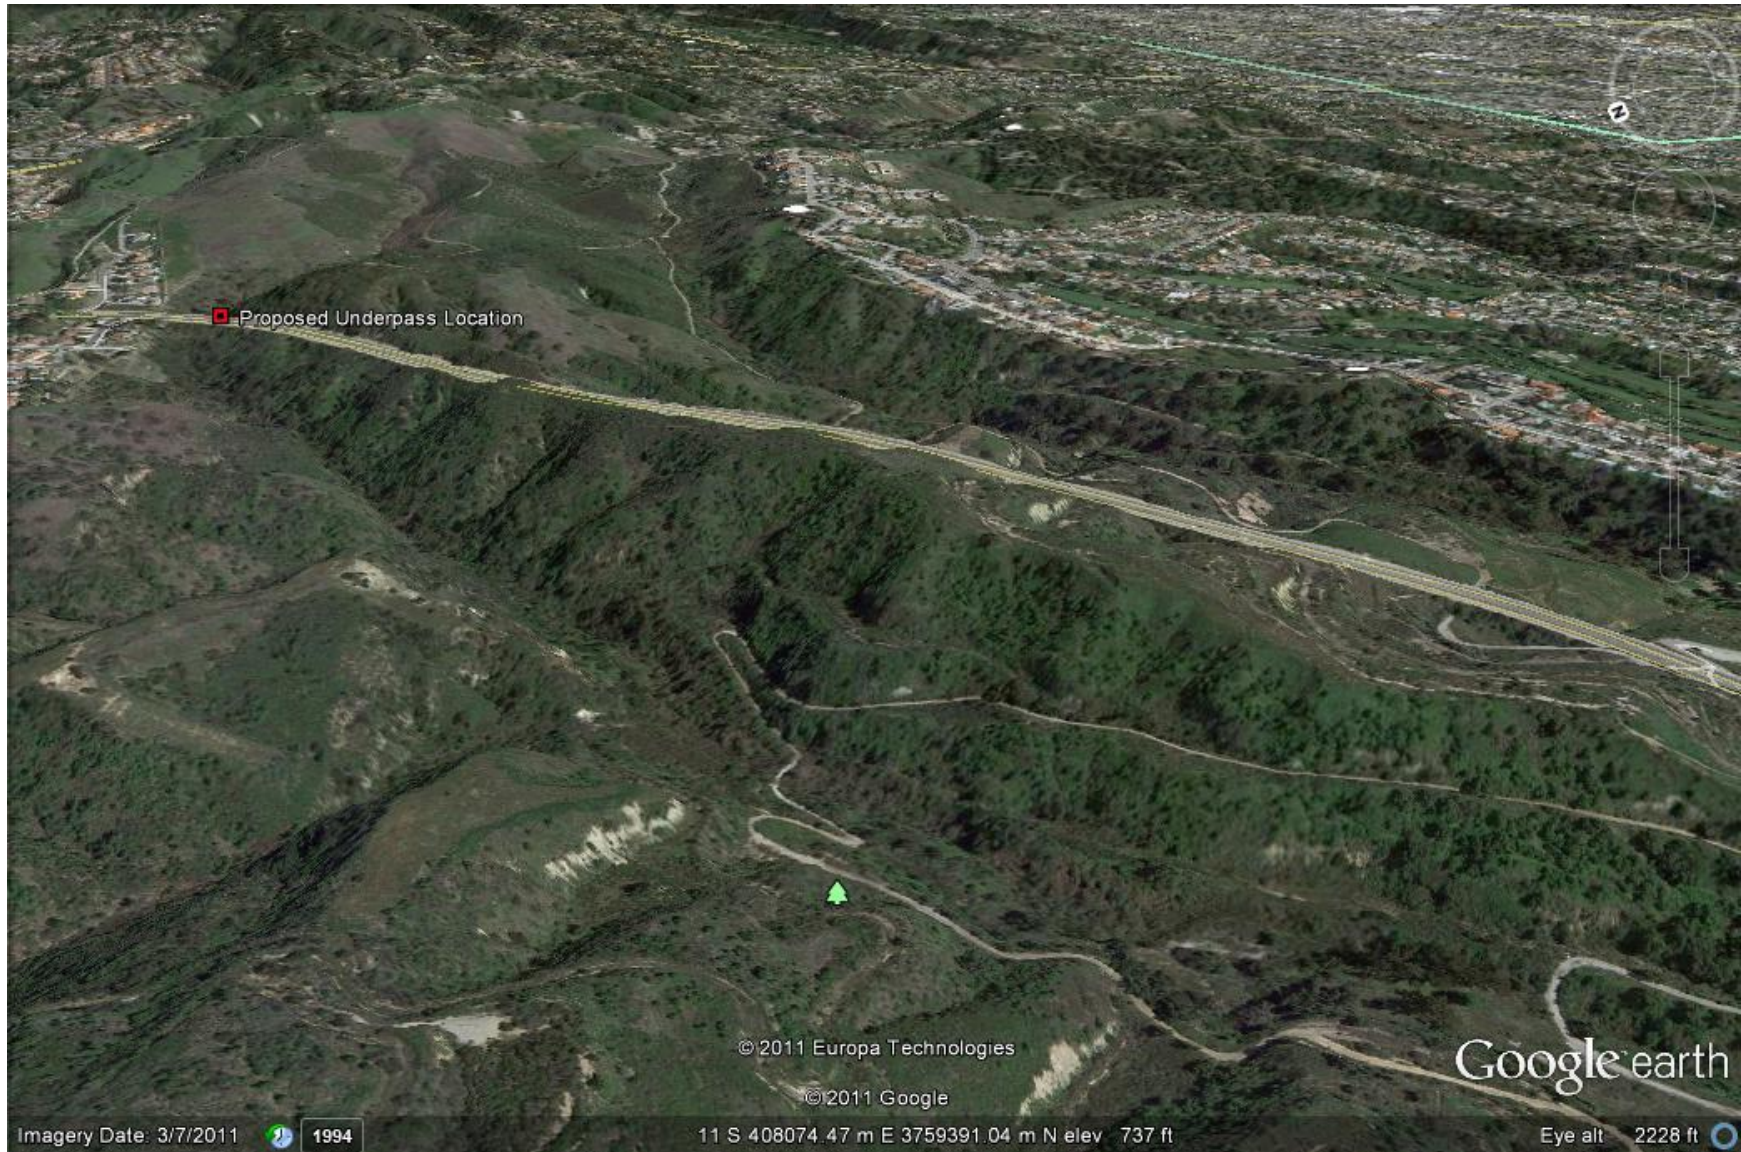
Figure 9. Looking east along upper Arroyo Pescadero (right drainage) at the proposed underpass location, west portal.

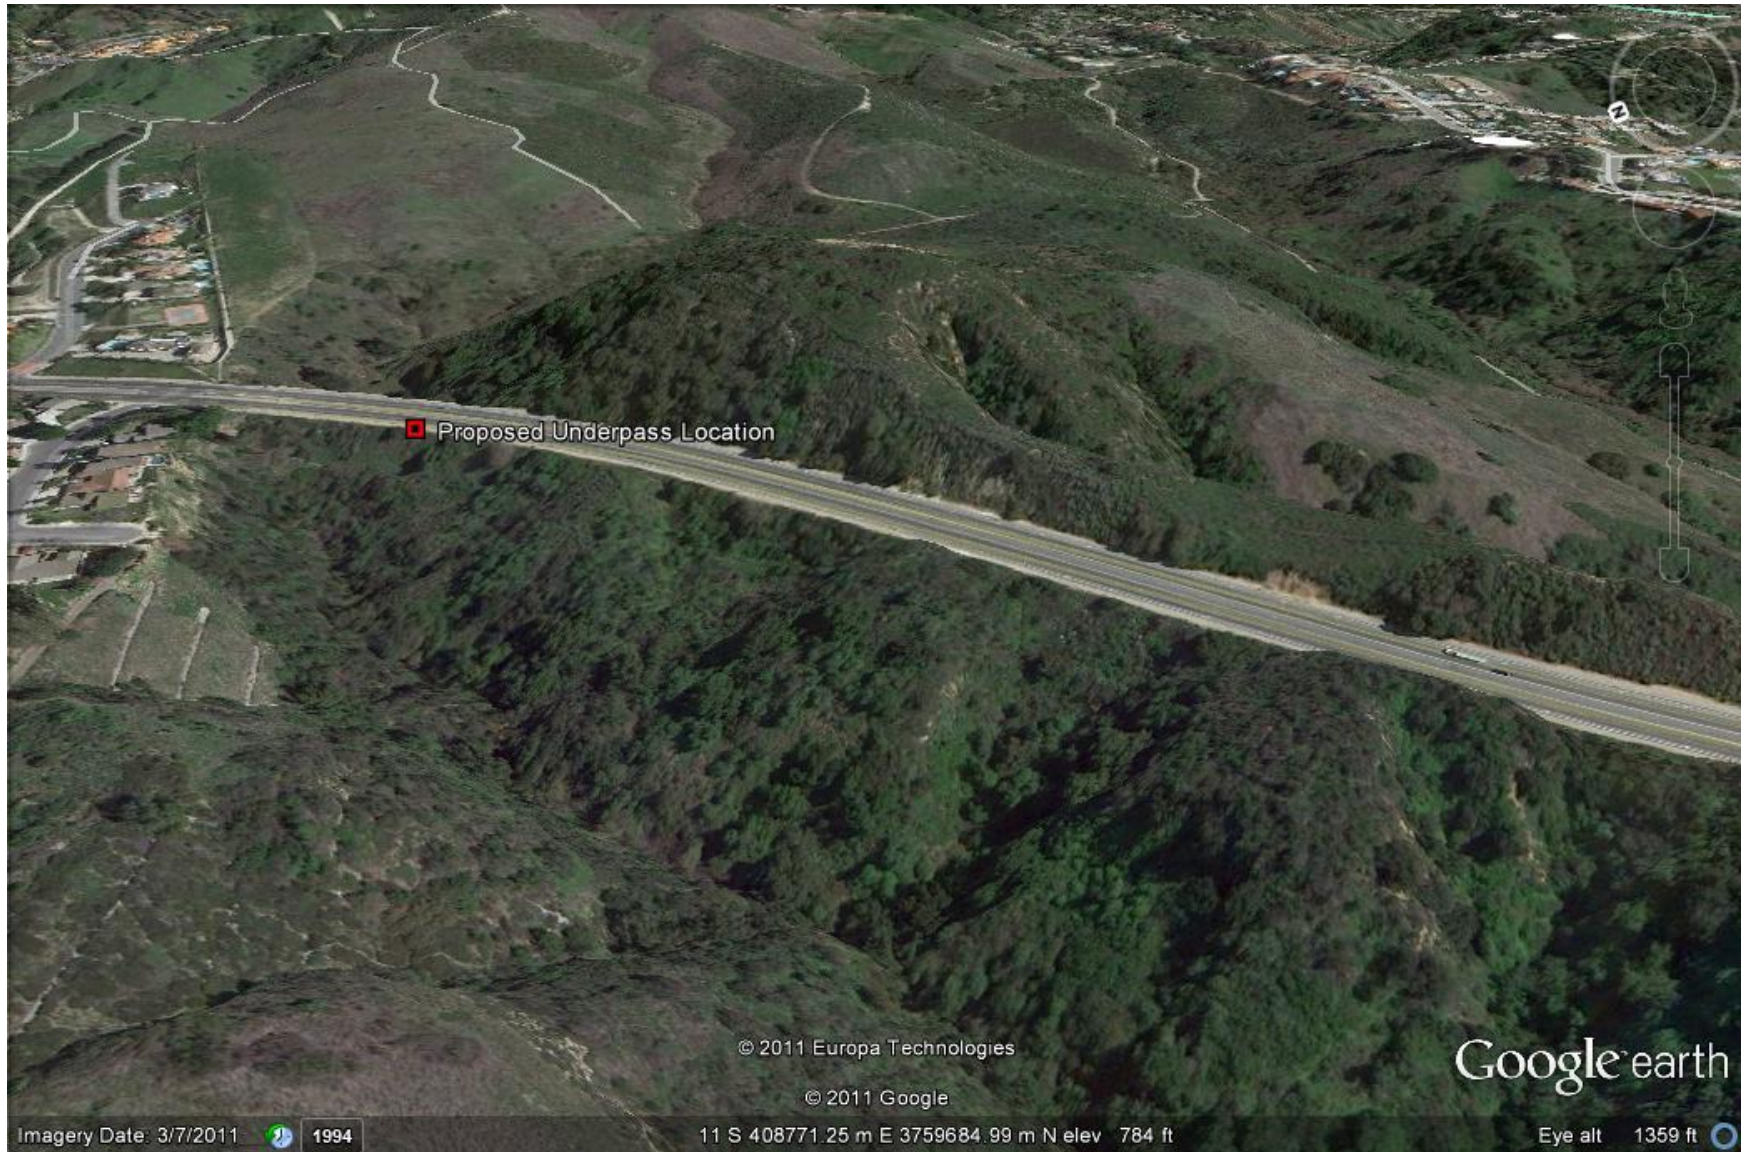
Figure 10. Looking east along upper Arroyo Pescadero (right drainage) at the proposed underpass location, west portal.
